Alan Breck I.Eng.M.I.C.E.  
ABC House & Extension  
Calculations Ltd  
E: alan@abccalcs.co.uk  
M: 07976308747  
W: www.abccalcs.co.uk

# Structural Report

24 Stone Road, Broadstairs

Date of inspection: 3<sup>rd</sup> June 2021

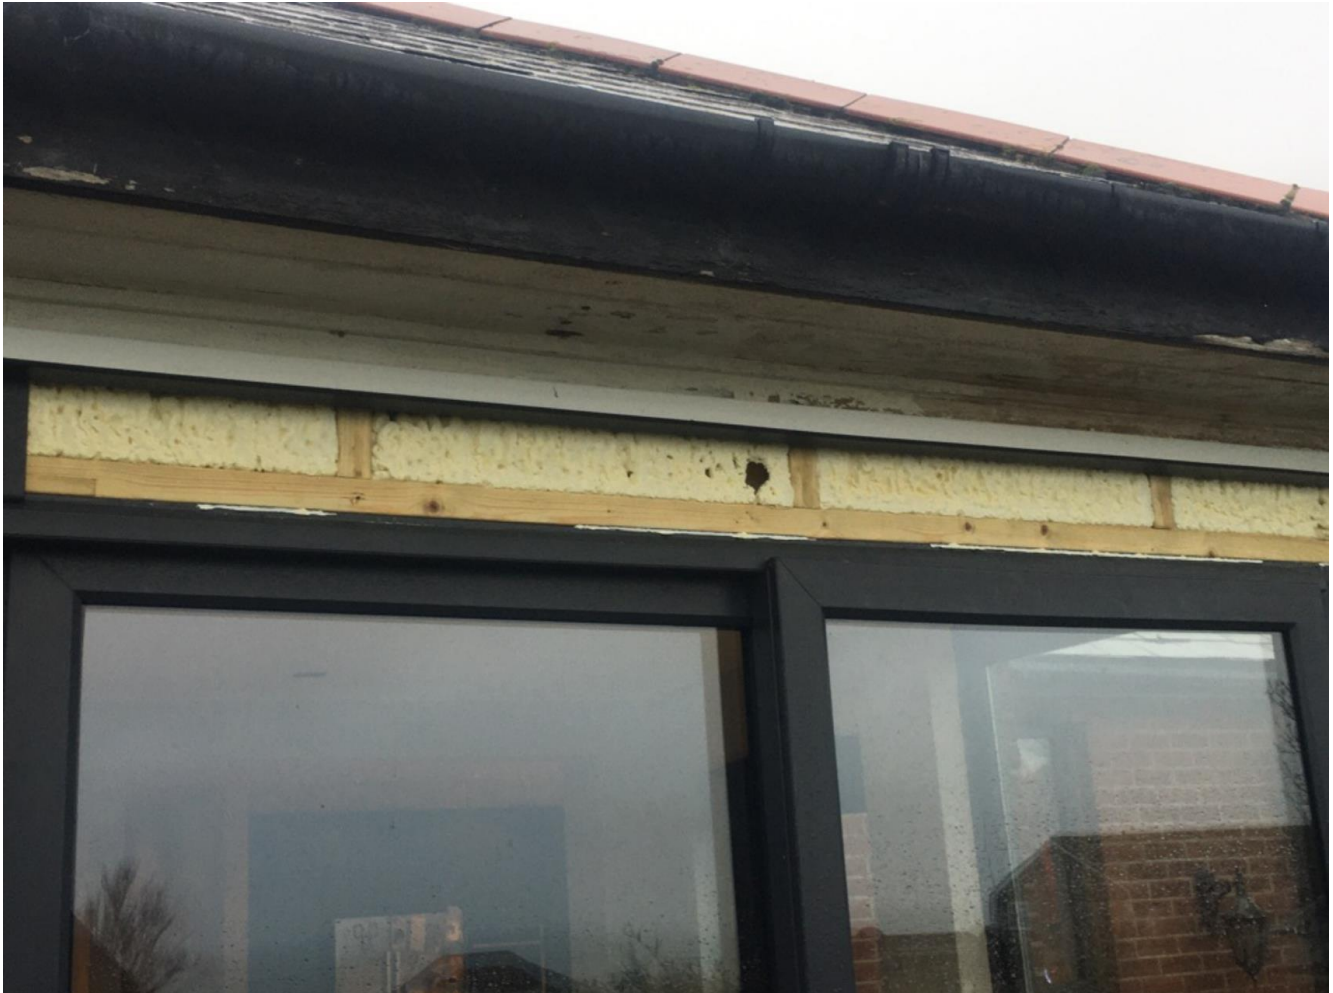
Upon inspection of the supporting beam, it has been constructed using 2 sections of timber 100mm x 47mm laid flat with small sections of timber installed between; commonly known as a 'ladder beam'

Due to the severe deflection in the ladder beam the internal ceiling has moderate cracking, and both sliding doors have become very difficult to open.

The ladder beam installed to support the opening is completely inadequate and will cause long-term deflection.

*Photo 1 – Showing inadequate timber ladder beam*

The beam needs to be completely removed and replaced with a structural beam such as a flitch or steel beam.
